NOISE MITIGATION OF OLD ÅRSTA RAILWAY STEEL BRIDGE

René Smidt Lützen¹, Anders Olsen²

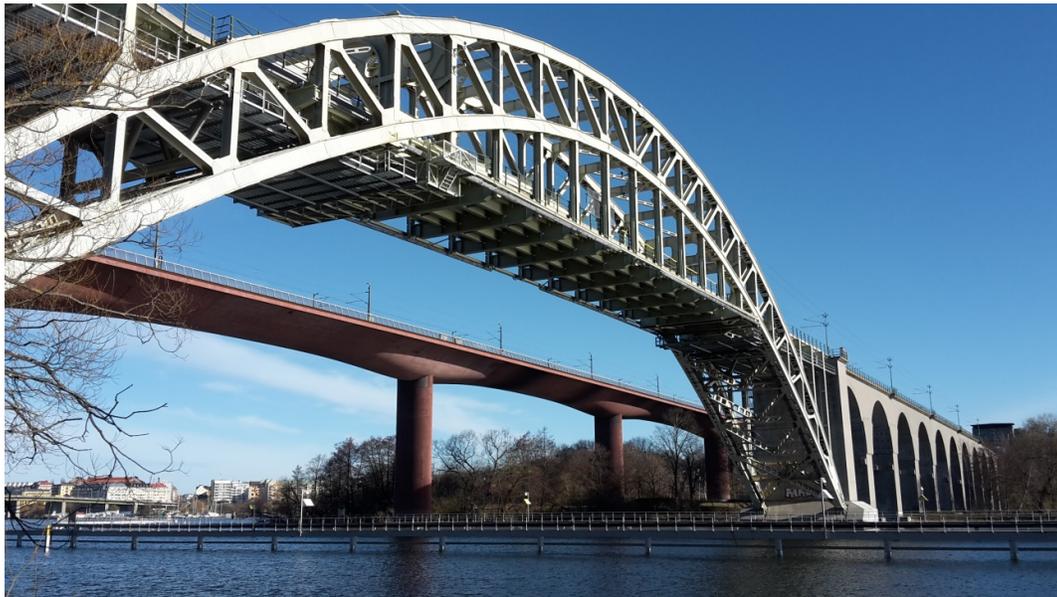
Figure 1. View from South East. In front, Old Årsta bridge. In the back, New Årsta bridge. Photo from April 2017.

The pre-study described previously in (1) involved both in-situ measurements and numerical modelling. Measurements included train passage noise registered at the New Årsta bridge (Pos A), located approximately 45 m to the west of Old Årsta bridge, see Figure 1. Also from the Old Årsta bridge, passages were captured using LR's in-house, 56 microphone array. Furthermore, vibration measurements on multiple components of the Old Årsta bridge were taken for each vehicle passage. For both noise and vibration, precise timing of vehicle passage was determined using accelerometers mounted to the underside of the deck at each end of the Old Årsta bridge.

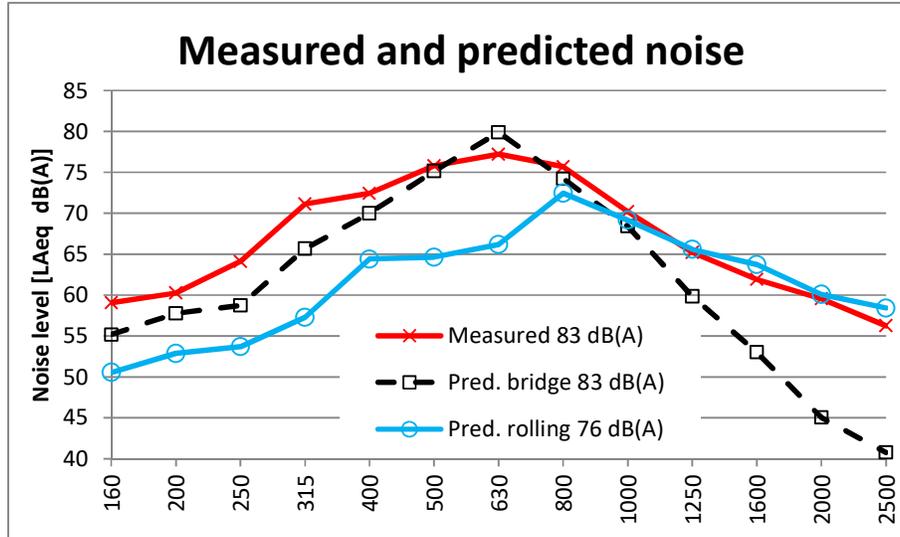
Figure 2. 1/3-octave noise spectra at Pos A for unmitigated bridge, predicted and measured

Passage of the steel bridge was typically around 6 s, with average overall LAeq,T (A-weighted, equivalent continuous sound pressure level, for time interval T) 83 dB(A). The 1/3-octave noise spectrum was dominated by the 500-800 Hz range, see Figure 2.

Using the numerical models it was found that frequency range up to 800 Hz was dominated by noise radiated by the bridge structure, “bridge noise”, see Figure 2. Above 800 Hz, the “train”, or rolling, noise took over and dominated. The deck and longitudinal girders were identified as the most significant contributors to the noise at Pos A.

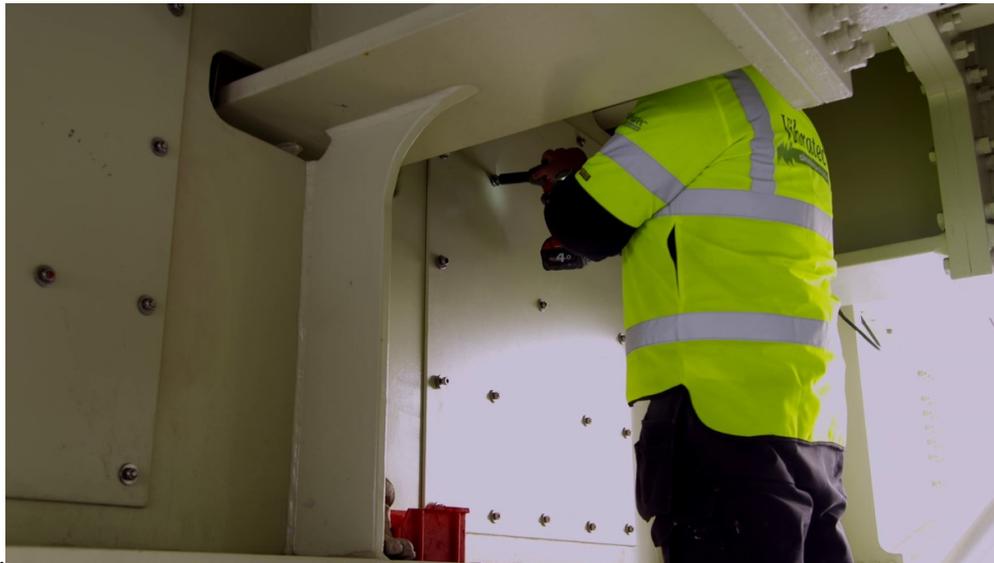
Figure 1. Mounting of CLD element onto transverse plate.

However, note that the current design is in fact a 3-layer system, since glue as well as bitumen layer have viscoelastic behavior. System and method were previously described in (0). Constraining steel sheets were of thickness 4 or 5 mm depending on specific CLD patch, and deck/girder thickness.

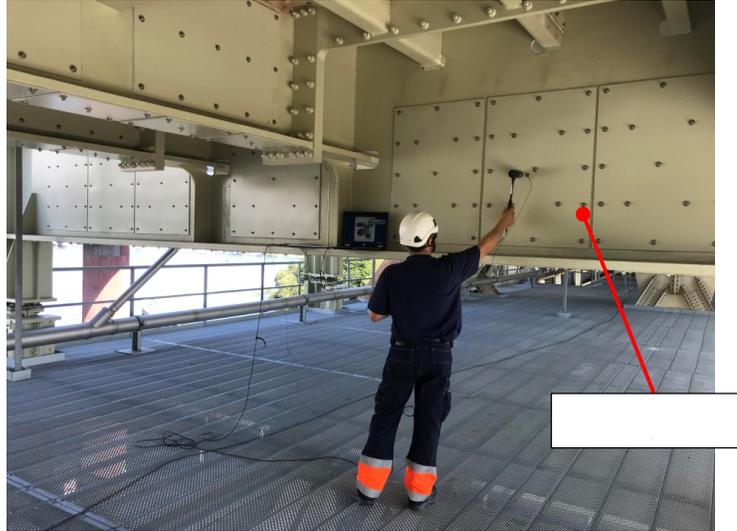
Figure 2. Point mobility measurement of transversal plate with installed CLD solution.

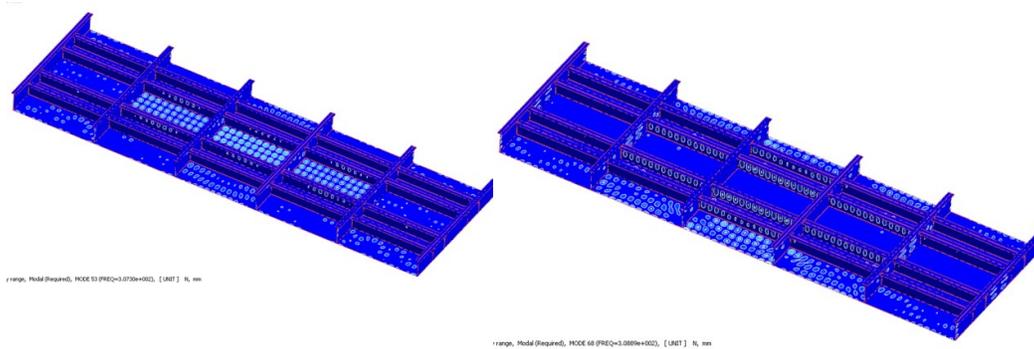
Figure 3. Examples of local modal patterns calculated using Finite Element. Left is 307.3 Hz. Right is 308.9 Hz. Bridge deck with girders is seen from below.

In further support for the selected element size, it is noted that the pre-study indicated that the lowest flexural modes (or natural frequencies) occurred in the 50-100 Hz range for the unmitigated plates. Hence, the target frequency range was significantly higher, implying a reasonable modal density. Vibratex created a 3D structural Finite Element model of a section of the bridge, using commercial software MIDAS NFX. A numerical modal analysis was performed for 200-900 Hz, and as expected a high modal density was found. Plots of modal patterns like the examples in Figure 3 were used to confirm that wavelengths for the 100-400 Hz range were indeed less than 1.25 m, as indicated by the coarse calculations of Table 1.

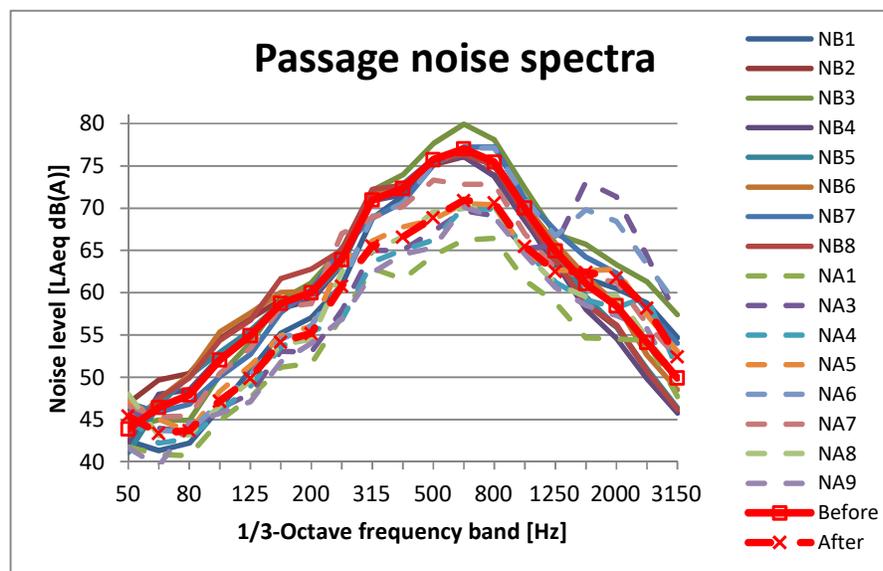
Figure 4. 1/3-octave band spectra at Pos A for all passages.

All steel bridge passage noise spectra are plotted in Figure 4, where continuous lines refer to before CLD installation, and dashed lines are after. The thick red lines are average spectra, before and after CLD installation. It is seen that spectra after CLD installation are generally below those before, for frequencies below approximately 1250 Hz. The reduction is particularly large in the range 400 to 800 Hz. Two of the spectra after CLD installation present an additional peak around 1.6 kHz, possibly due to wheel tread defects. Ignoring these peaks would only affect the reduction estimate by approximately 0.2 dB.

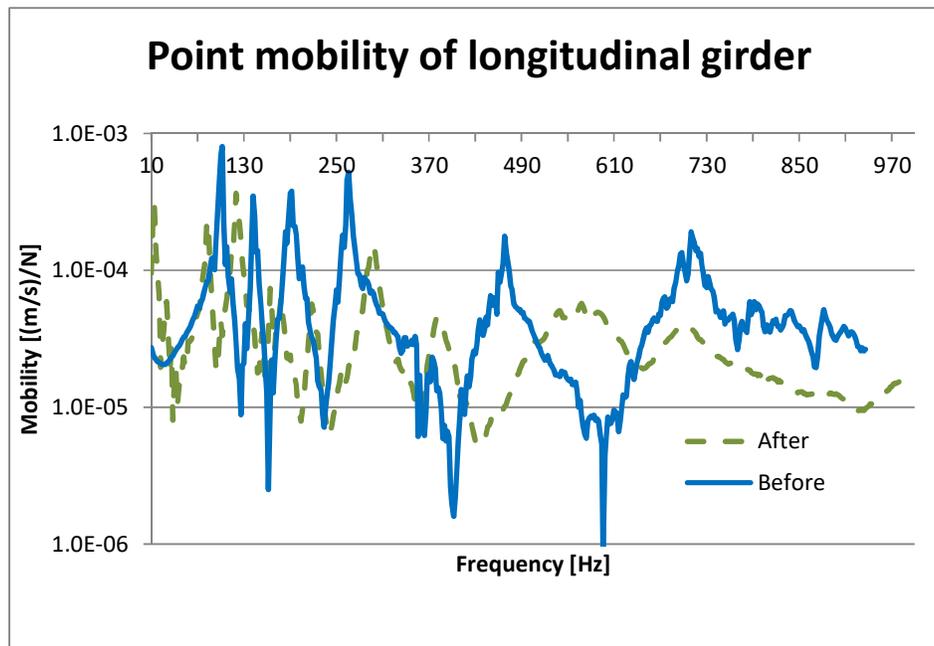
Figure 5. Narrow-band point mobility spectrum of longitudinal girder. Frequency resolution is 2 Hz. No data window was applied. Mobility units are acceleration [(m/s²)/N]. Average of 10 impacts. Curves are before and after CLD installation.

As an example, the point mobility of the longitudinal girder is shown in Figure 5, for the same measurement position before and after CLD installation. Plate modes appear with natural frequency at about 100 Hz. Clearly, the mobility curve seems to have been reduced in level after CLD installation, and particularly above approximately 300 Hz the peaks have been broadened out due to increased damping. Application of the MDOF curve fitter identified the natural frequencies and corresponding damping ratios as shown in Figure 6. A clear damping increase is seen, from roughly 1% before to 2% after. No modal shape information was available from the measurements, since only a single hammer/accelerometer position was investigated. It seems likely, however that modes with practically the same natural frequency and damping ratio before and after CLD installation were not bending modes. Hence, they probably do not have significant noise radiation during vibration.

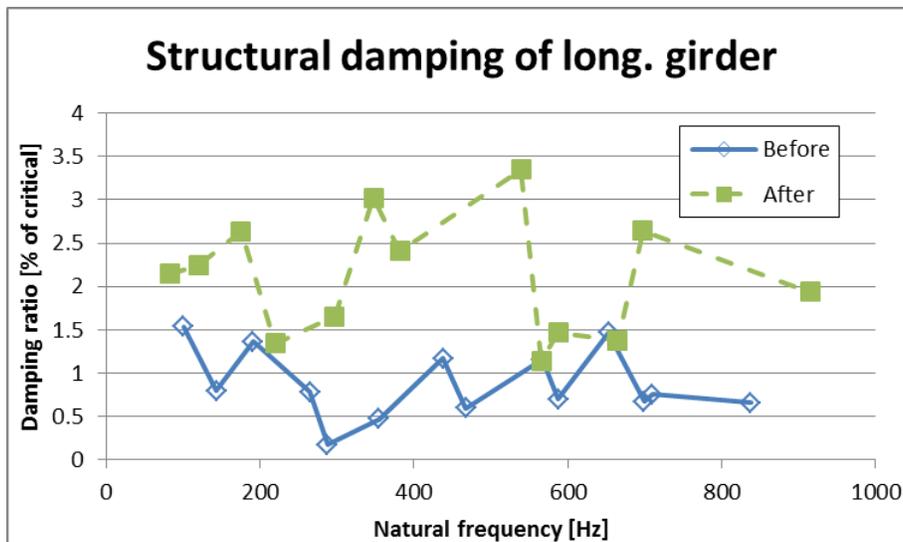
Figure 6. Structural damping ratio of longitudinal girder in per cent of critical damping, before and after CLD installation..

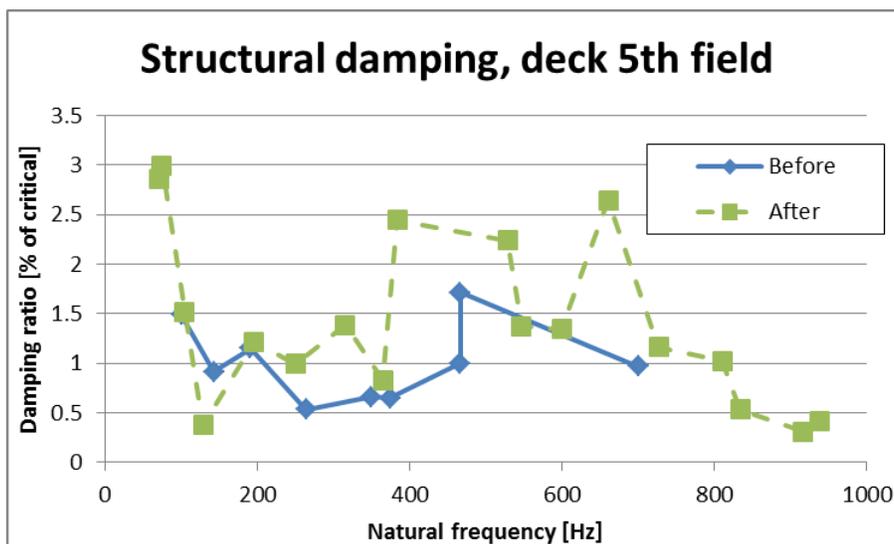
Figure 7. Structural damping ratio of deck field in per cent of critical damping, before and after CLD installation.

Similarly, Figure 7 shows the structural damping for one of the steel deck fields. As the example illustrates, the damping improvement for the deck was found to be less pronounced (about 0.5% increase for 400 to 800 Hz), and less consistent across frequency. This was also found for other deck fields.
